CORDUROY CROSSING

NORTHEAST RELIABILITY INTERCONNECT PROJECT

FIGURE 11 CORDUROY CROSSING

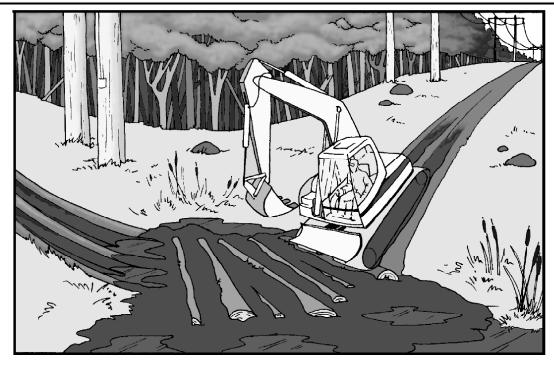
IMPROPER INSTALLATION

- Area is too wet for proper application of corduroy
 - Insufficient corduroy to support equipment
 - Corduroy is sunken into wetland soil
- Approaches are steep, rutted, and are not protected with additional corduroy or mats

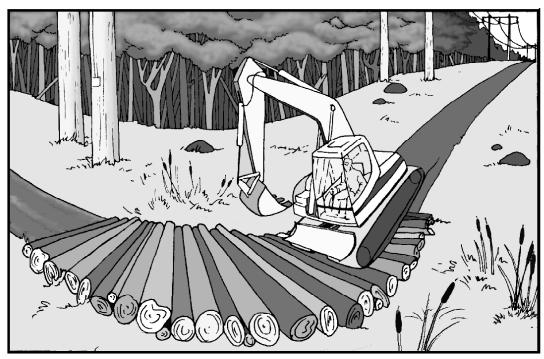
PROPER INSTALLATION

- No flowing or standing water or saturated soil present
- •Adequate amount of layered corduroy to protect soil from rutting
- Approaches are protected from rutting by extension of corduroy beyond edges of crossing
